National Park Service
Cultural Landscapes Inventory
2009

Jordan Pond House
Acadia National Park

Inventory Unit Summary & Site Plan

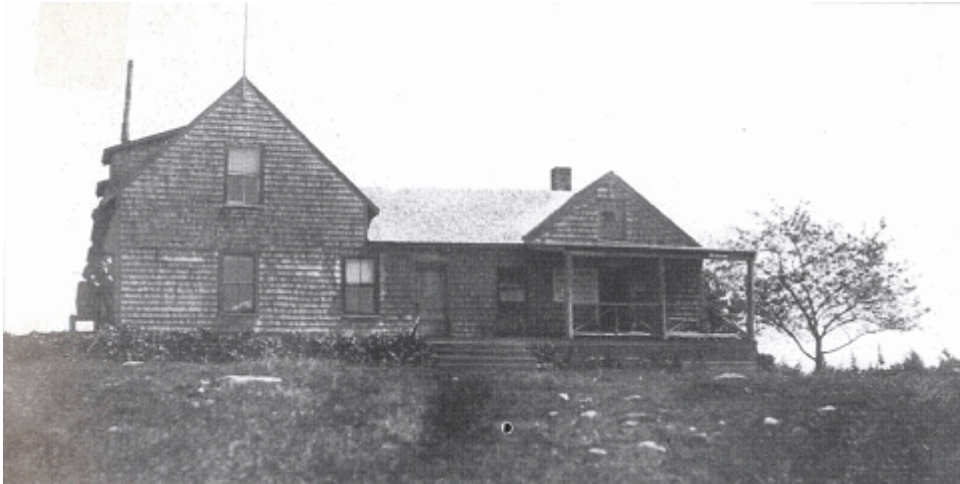
Figure 2. Photograph of the Jordan Pond House in 1898, view looking southwest . The Jordan Pond House attracted resorters to its dining room for afternoon tea and prepared picnics (Acadia NP archives).

quality food and service for the growing number of summer colony residents in the area. From the start, the chicken and popover dinners attracted people from all the different villages on Mount Desert Island (Figure 2) (CLI, 1996: 4).

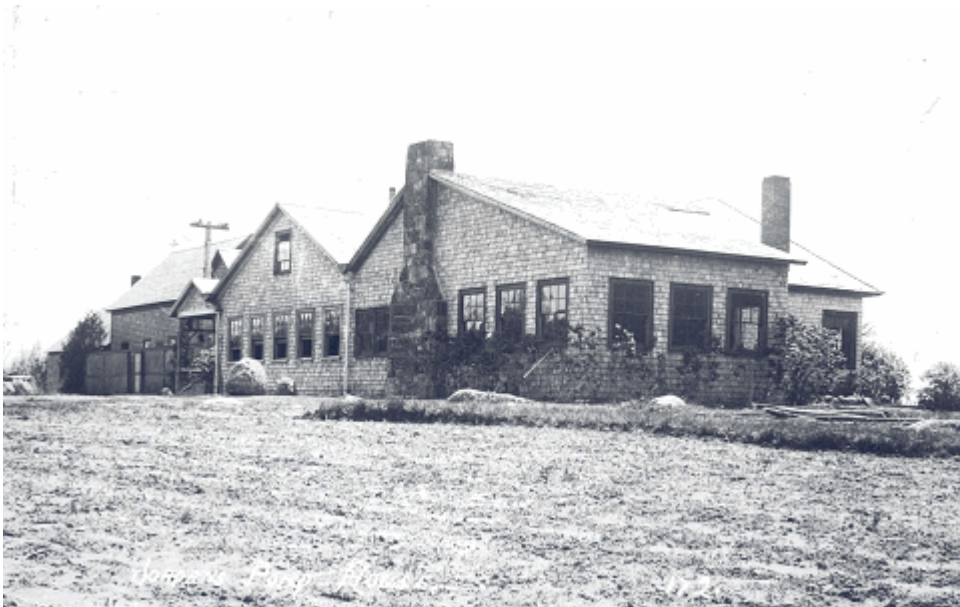
Figure 4. Photograph of the Jordan Pond House and landscape, c. 1910, view looking southwest. Note the rustic, rambling nature of the house (Acadia NP archives).

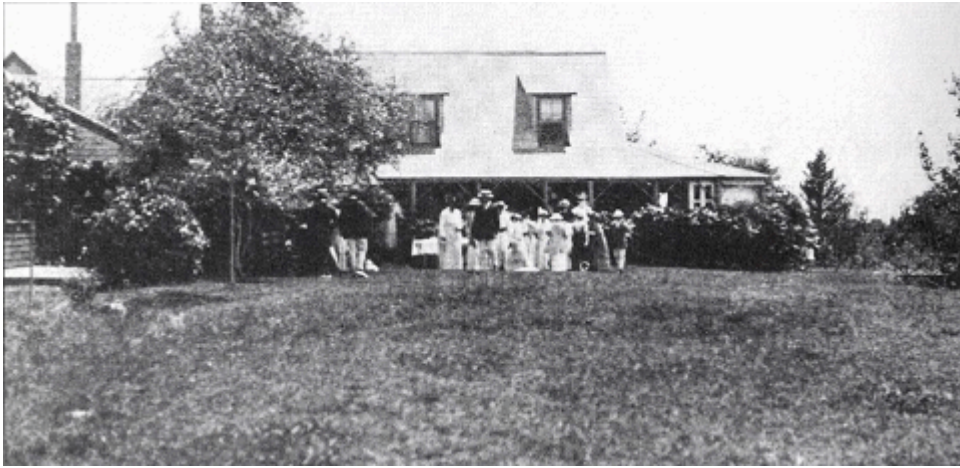
Figure 6. Photograph of the Jordan Pond House tea lawn, c. 1915, view looking south. Note the manicured lawn area, foundation plantings, and juvenile trees (Acadia NP archives).

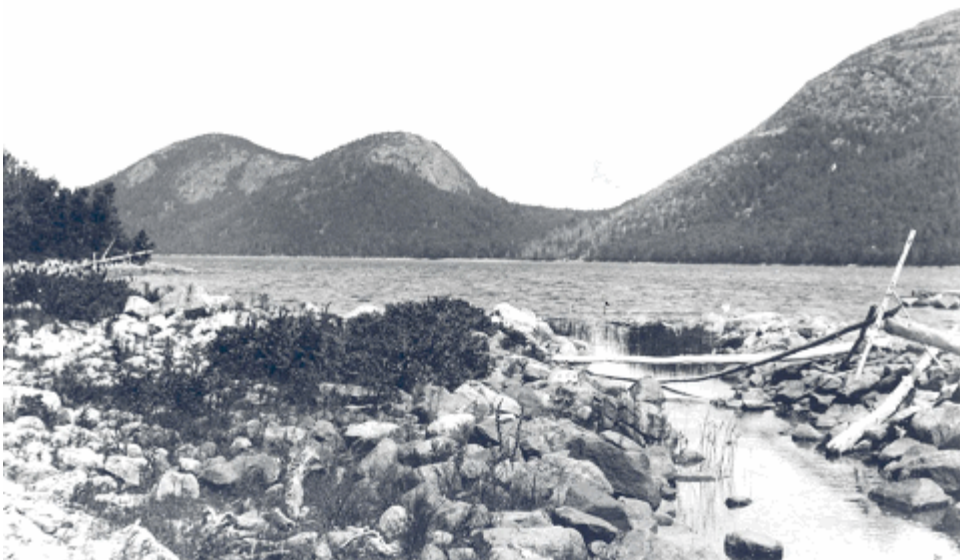
Figure 7. View looking northeast at Jordan Pond and Jordan Stream, 1892. Presently the location of the Jordan Pond Dam and Spillway (Acadia NP archives).

Other improvements sought by the VIS addressed water quality. George Dorr, founding member of the Bar Harbor Village Improvement Association, wrote about an effort to preserve the watershed of Jordan Pond for the benefit of Seal Harbor. Jordan Pond had been the drinking water source for the village since the 1890s. In 1896 the Seal Harbor Water Company condemned land at the outlet of Jordan Pond to build a pump house and dam spillway (Figure 7). In the process of building the dam they most likely destroyed any remnants of the Jordan sawmill.

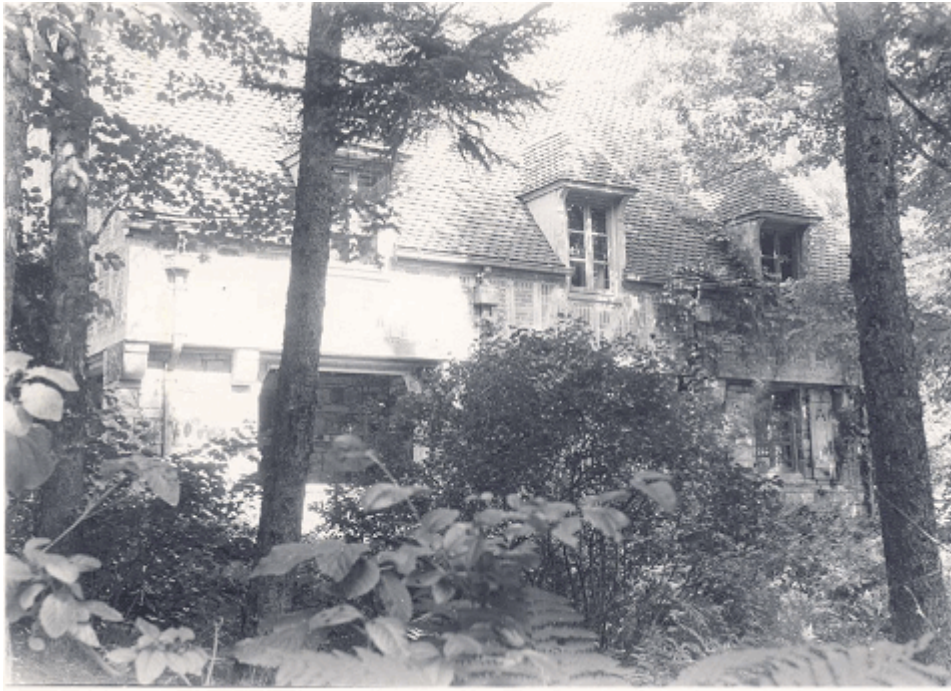
Figure 8. Photograph of the Carriage and Gatekeeper's House, c.1946. The naturalistic and informal landscape enhances its picturesque qualities (Acadia NP archives, 2582).

Rockefeller continued to develop the area around Jordan Pond House after he purchased the property. In 1929, Rockefeller felt it necessary to ensure automobiles were not allowed access to the carriage roads. Rockefeller chose to construct a gatehouse complex, which included a carriage house, gatekeeper's house, and east and west gates. Although four gatehouses were designed, only two were ultimately constructed. Grosvenor Atterbury was hired as architect for the gatehouses. The construction of the Jordan Pond and Brown Mountain Gatehouses were completed in 1932 (Figure 8) (CLI, 1996: 12).

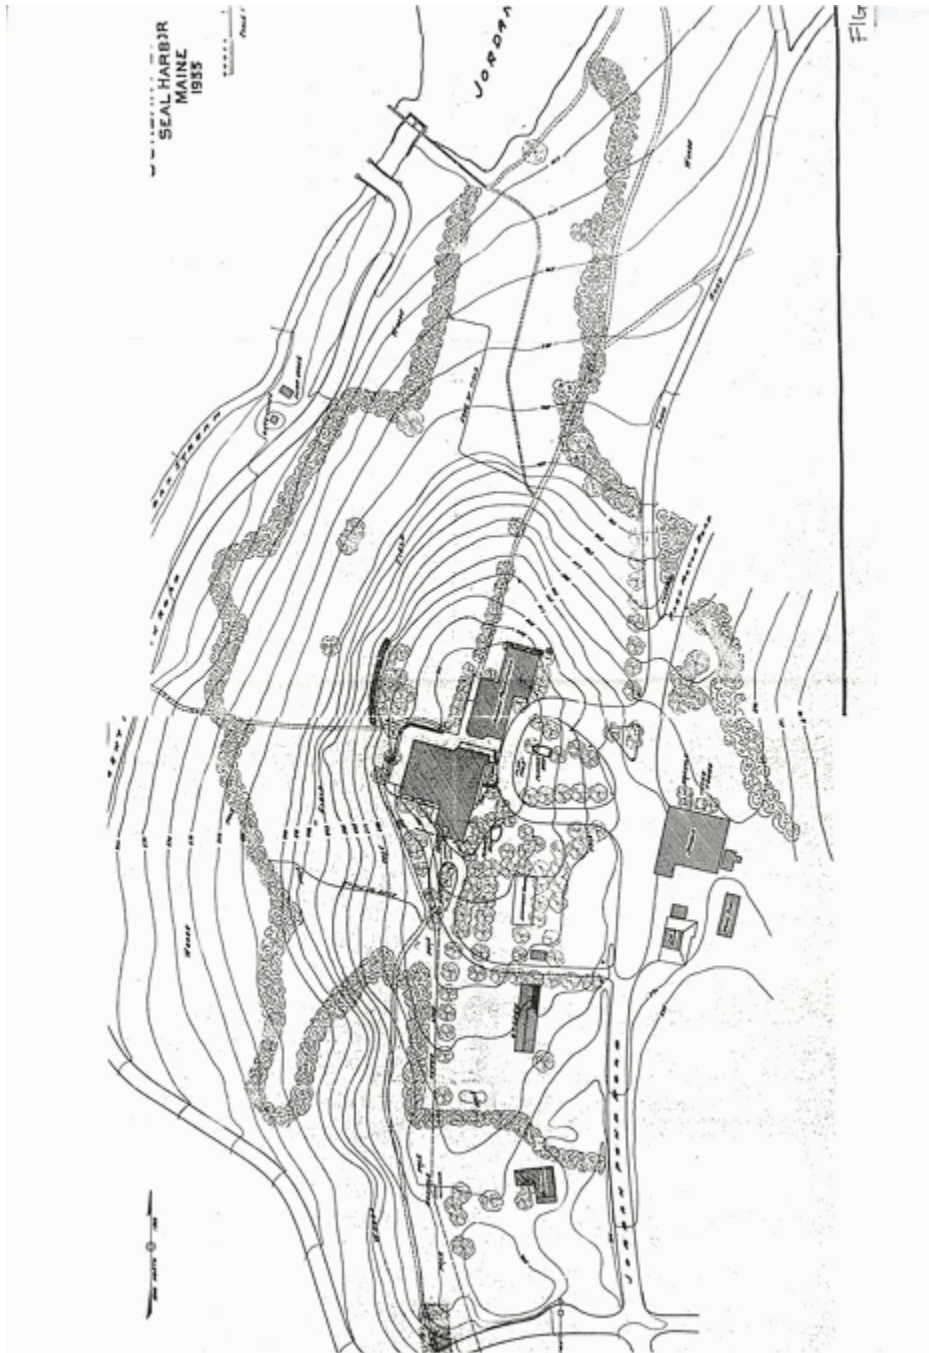
Figure 9. A 1933 topographic map of the Jordan Pond House site. The plan depicts the circulation systems, vegetation, buildings, natural systems, and small scale features found in the area (Acadia NP archives).

The last circulation system on the 1933 plan, are the hiking trails. Three paths started at the tea lawn; to the south, Seaside Trail [Trail #401] to Seal Harbor, to the west, down to a carriage road and across Jordan Stream to hiking trails, and to the north, along the edge of the cleared field to the pond edge. This last trail to the north forked, one path crossed through the shrubby growth within the vista to the pond spillway (this could be the nature trail installed in 1928), and the other section continued along the edge of the vista to the pond shoreline, where a trail continued around the entire pond. One other trail from this segment veered to the northeast and continued to Bubble Pond. Some specific landscape features are also depicted on this map including an apple orchard on the east side of the main house, a laundry yard, two flower beds surrounded by the stones, and a flagpole at the front entrance to the restaurant. A small vegetable garden is depicted to the south of the service road to the main building. The last feature of note is a bench shown on the pond shore (CLI, 1996: 14).

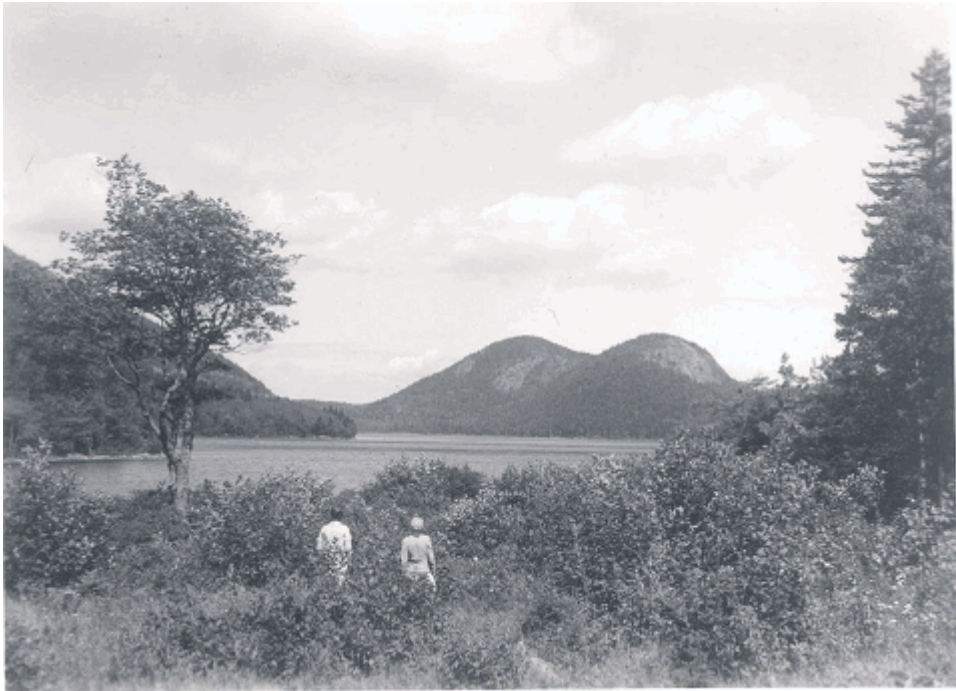
Figure 10. Jordan Pond House tea lawn, date unknown, view looking north. Although highly manicured near the Jordan Pond House, the tea lawn is maintained as low shrubby growth as it gets closer to Jordan Pond (Acadia NP archives, 2680).

In 1933 a topographic map was produced for the Jordan Pond House site and is the first detailed plan of the area (Figure 9). Circulation systems, vegetation, buildings, natural systems, and small scale features are all depicted on this map. Starting from the main building, the Jordan Pond House, two buildings were connected with a covered porch, and overall resembled a rambling structure, due to the many additions to the original farmhouse. The northern part of the building included the music room, birch bark dining room, and gift shop/office. Other alterations were made to the original house with the addition of kitchen services to the east of the main building. The covered porches facing the north and west were setup for table service, as was the lawn area. A hedge fronted the north facing porch, and deciduous trees on the west and east side of the lawn directed the view to the pond and The Bubbles. Within this vista, there was defined edge between the mowed lawn or field and the low shrubby growth (possibly blueberry patch). One lone tree was within the vista near the pond shore (Figure 10) (CLI, 1996: 13).

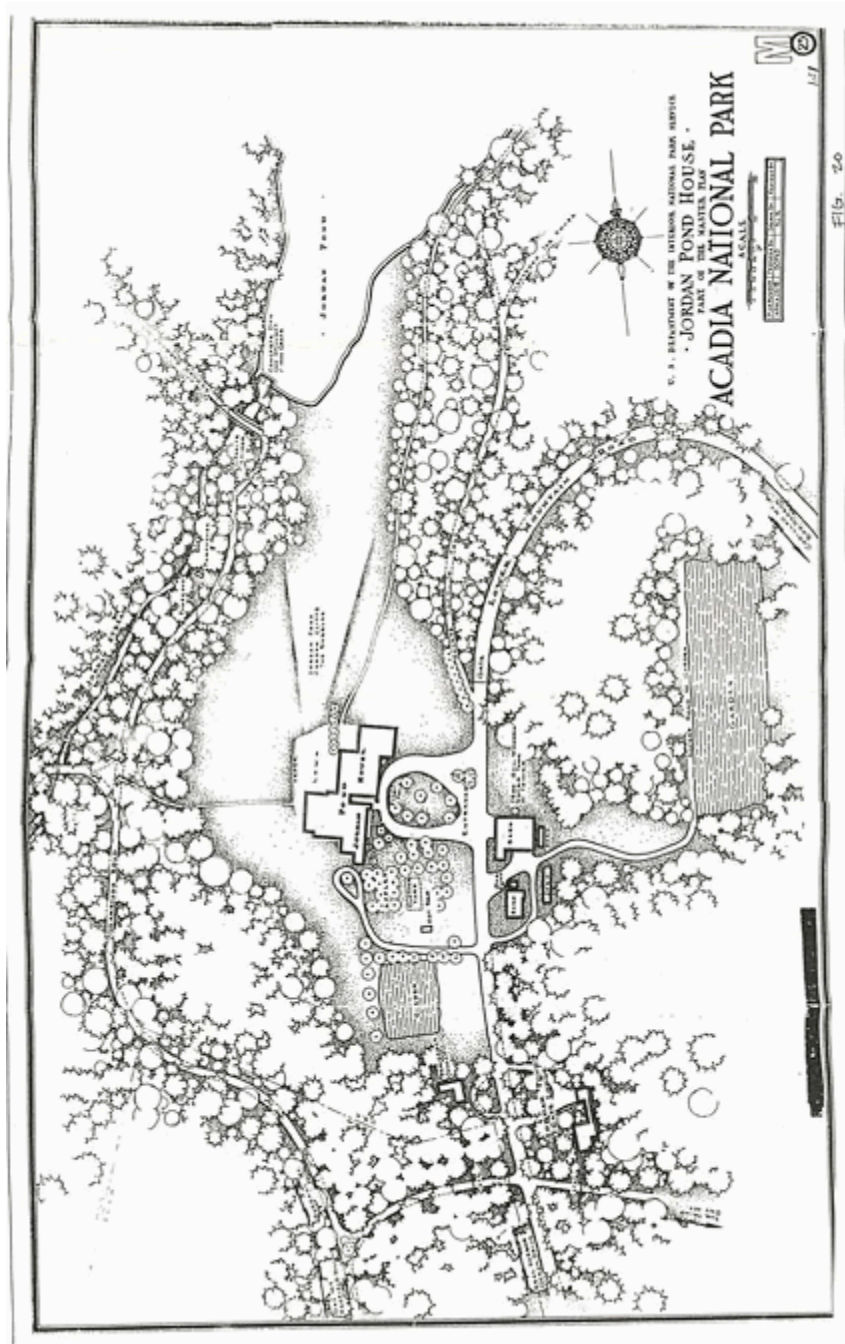
Figure 11. A 1940 Master Plan for the Jordan Pond House site. The plan depicts the circulation systems, vegetation, buildings, natural systems, and small scale features found in the area (Acadia NP archives).

A master plan was developed for the Jordan Pond area once the NPS obtained ownership, which showed the existing conditions of the site (Figure 11). This is the second detailed map developed for the Jordan Pond House property, and provides a broader survey than the previous existing conditions plan from 1933. The 1940 map depicts some differences from the earlier plan view. Instead of just one small vegetable garden, near the main building, McIntire expanded this garden and also cultivated another garden three times the size to the east of the service area. They gained access to the largest garden by way of a road from the service area. Other changes include abandonment of the ice house on the eastern shoreline of Jordan

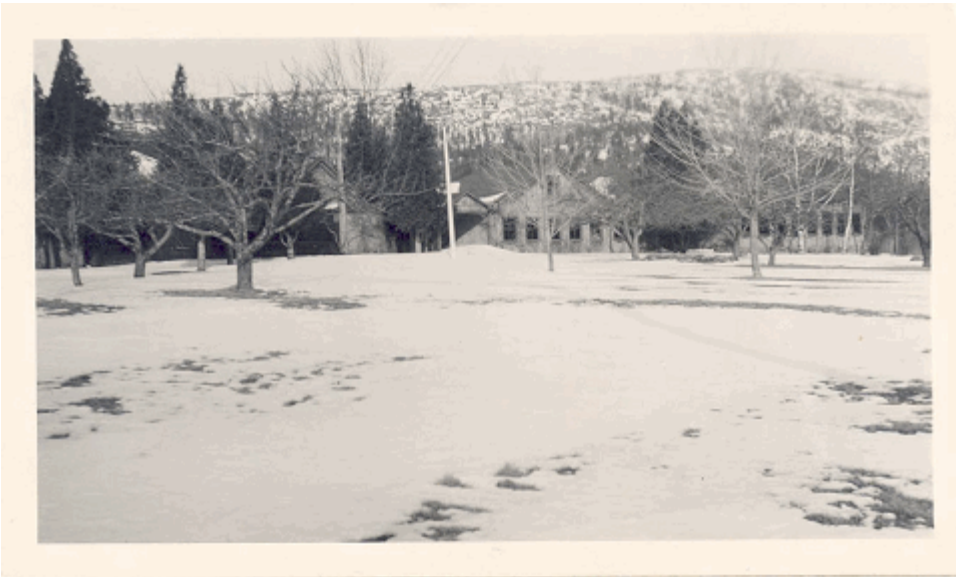
Figure 13. View looking west at the Jordan Pond House, 1951. Note the apple orchard to the left, flag pole in the center, and cedar trees near the building (Acadia NP archives).

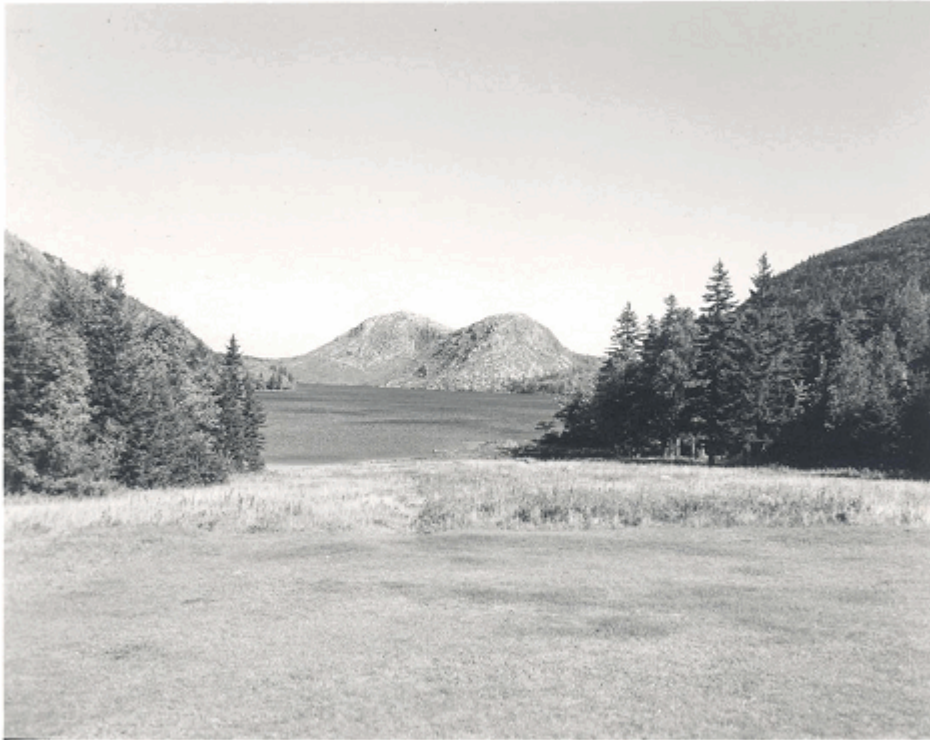
Figure 14. View looking north of the tea lawn and Bubble Mountains, 1958. The open character of the tea lawn has remained the same since the historic period (Acadia NP, 0072).

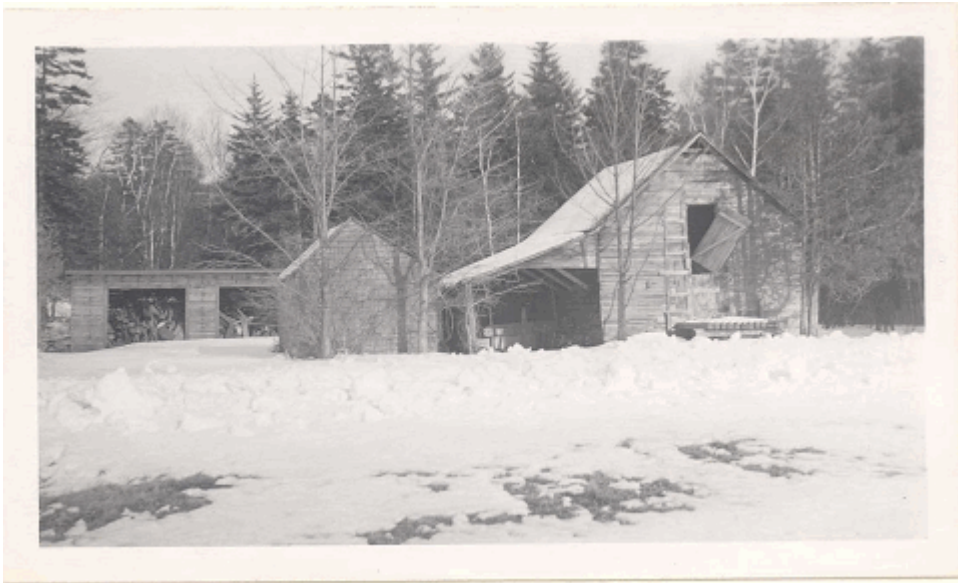
Figure 16. View of the ice house and shed located on the eastern edge of Jordan Pond Road (Park Motor Road), 1951. The buildings were removed following the realignment of the road (Acadia NP archives).

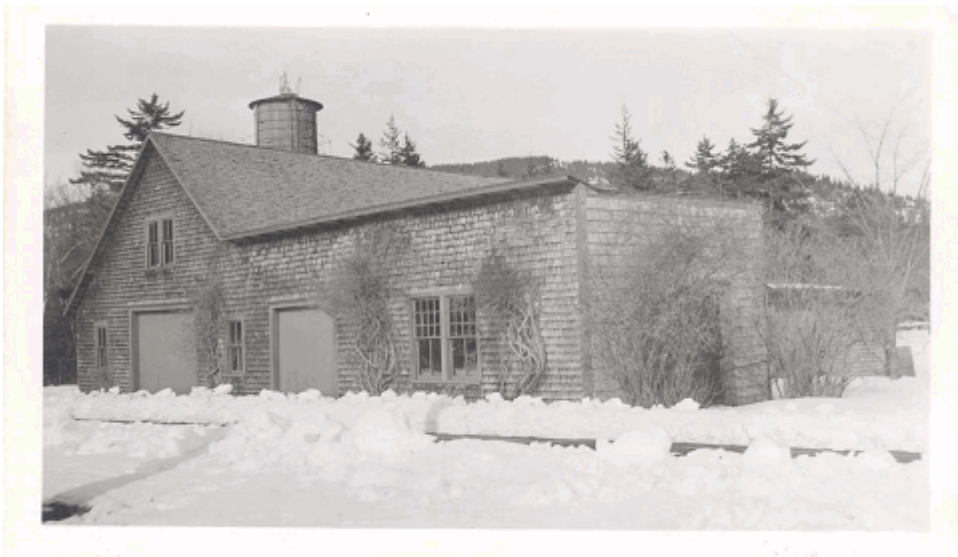
Figure 17. View of the stable and garage on the eastern edge of Jordan Pond Road (Park Motor Road), 1951. The buildings were removed following the realignment of the road (Acadia NP archives)

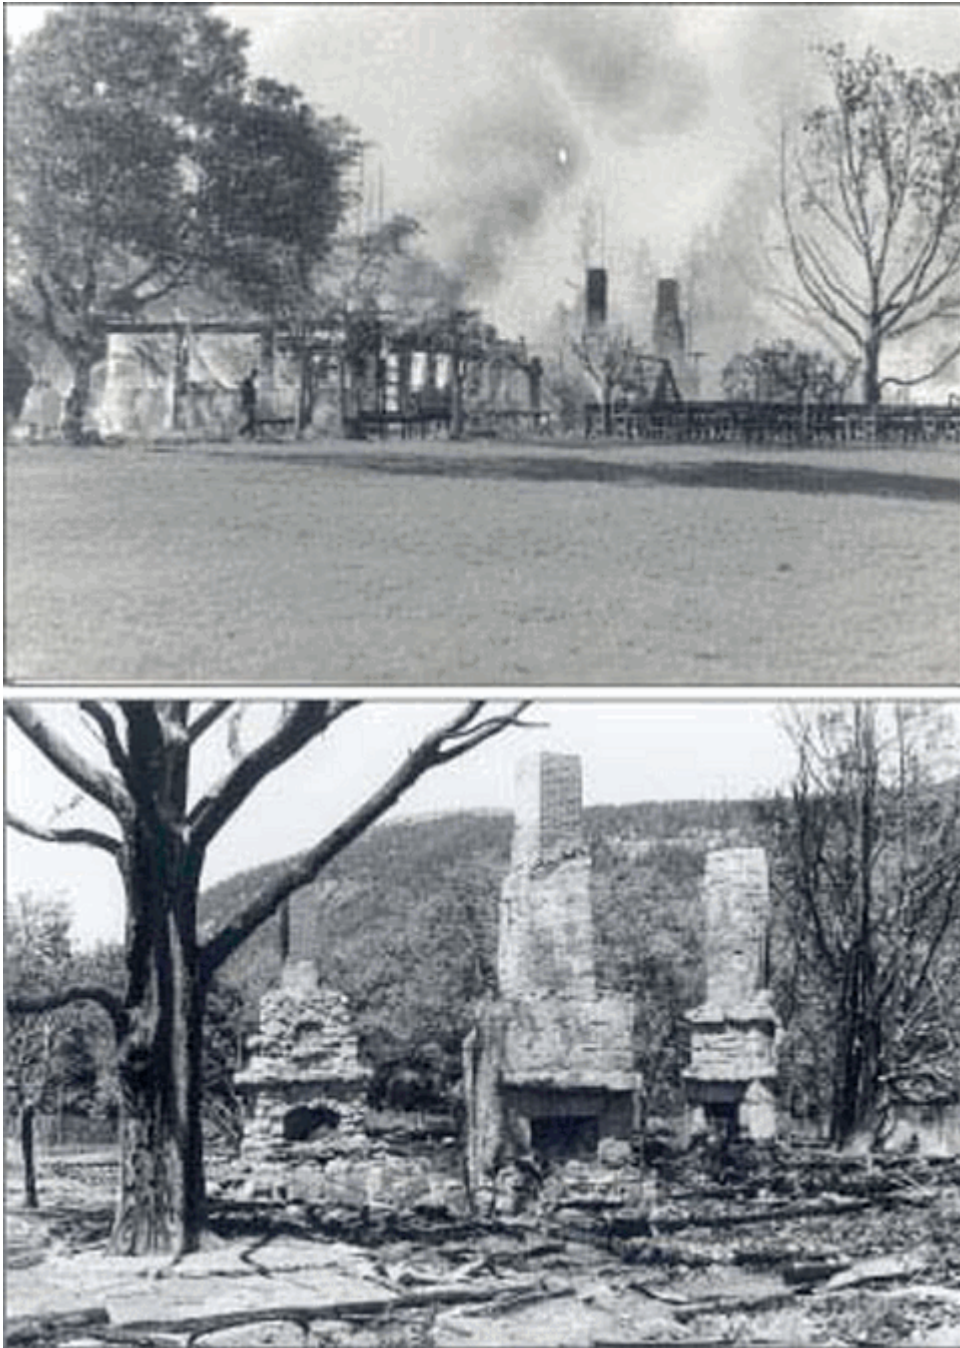
Figure 19. Views of the Jordan Pond House following its destruction by fire in 1979. The Jordan Pond House was rebuilt in 1982 (Acadia NP archives).

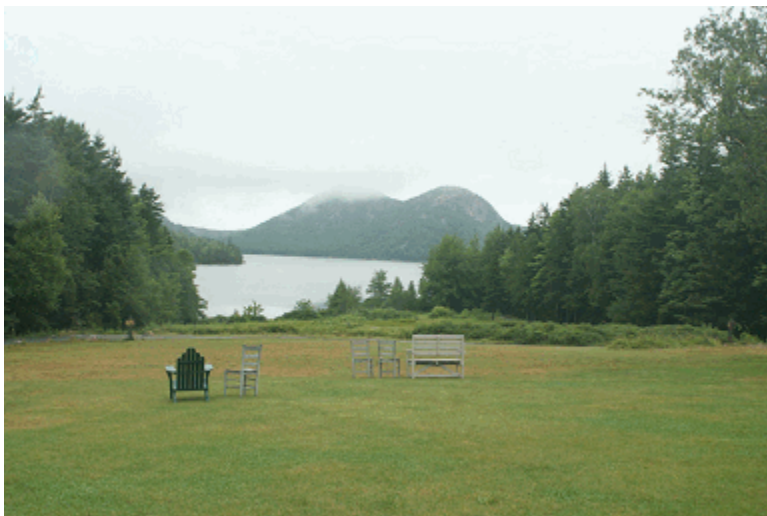
Figure 21. View of the tea lawn, social paths, low shrubby growth (blueberry thickets) and Jordan Pond. From this vantage point, The Bubbles can be seen in the distance, view looking north (OCLP, 2008).

Since the historic period, views from the Jordan Pond house and the tea lawn have been maintained to emphasize the natural features: Jordan Pond punctuated by The Bubbles to the north, and framed by the Penobscot Mountain to the west and Pemetic Mountain to the east. The trees closest to the tea lawn were planted to direct the eye to the vista, and farther away from the tea lawn the native woodland vegetation is maintained along a prescribed sight line to frame the view. Currently, the low shrubbery growth within the tea lawn is maintained through a prescribed burn (see Figure 21) (CLI, 1996: 29).

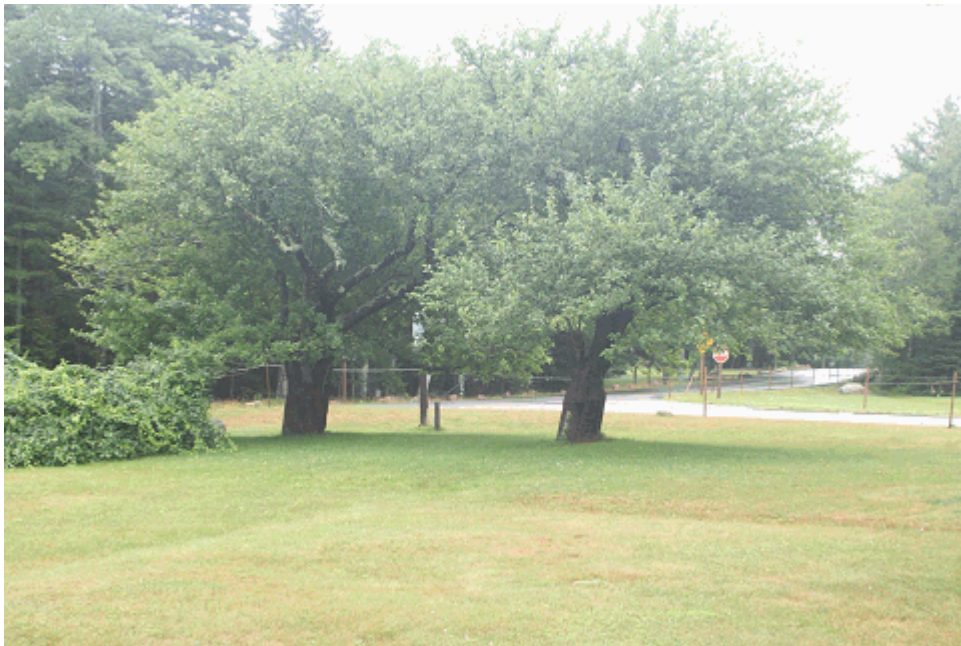
Figure 22. View looking south at two apple trees, remnants of the apple orchard that existed during the historic period. Jordan Pond/Eagle Lake Road is at center, view looking south (OCLP, 2008).

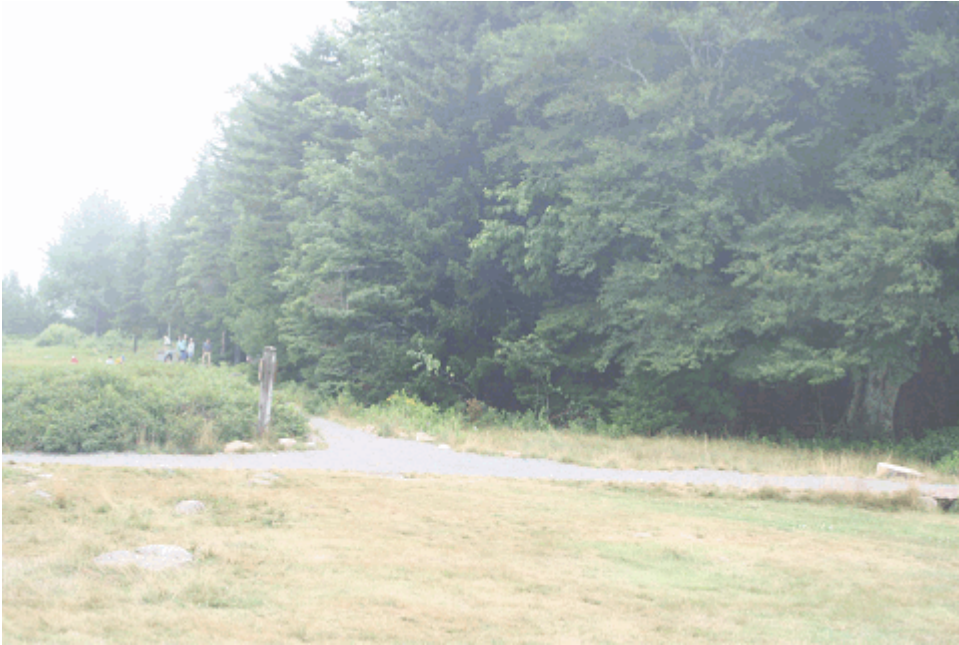
Figure 23. View looking northeast towards the Jordan Pond Nature Trail (current location) the eastern edge of the tea lawn. A white birch tree can be seen in the foreground. White birch trees once lined the eastern edge of the tea lawn (OCLP, 2008).

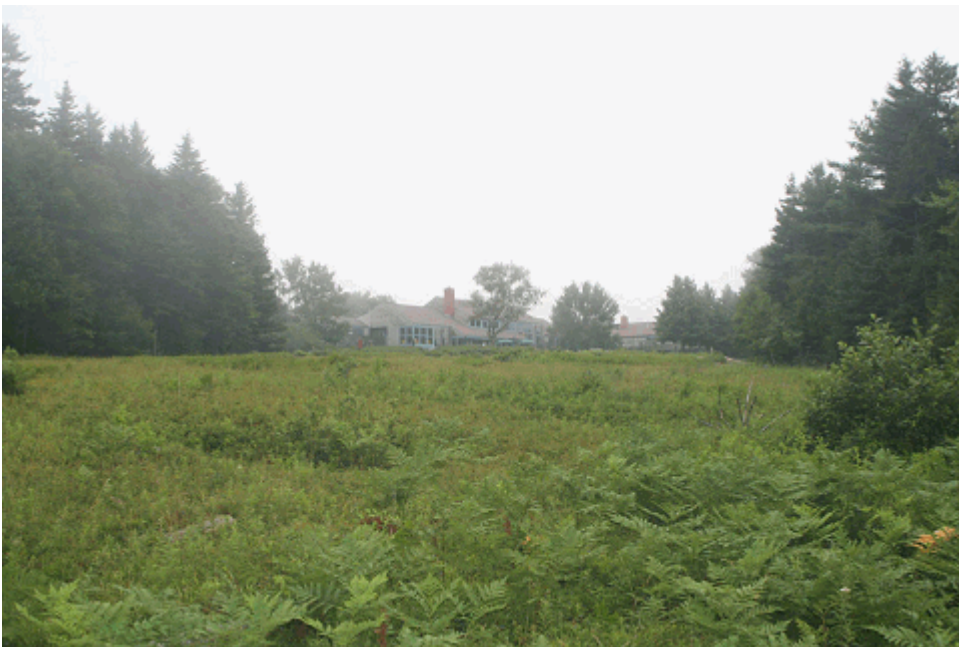
Figure 24. View looking southeast at the low shrubby growth (blueberry thicket) in the tea lawn area. The Jordan Pond House can be seen in the distance (OCLP, 2008).

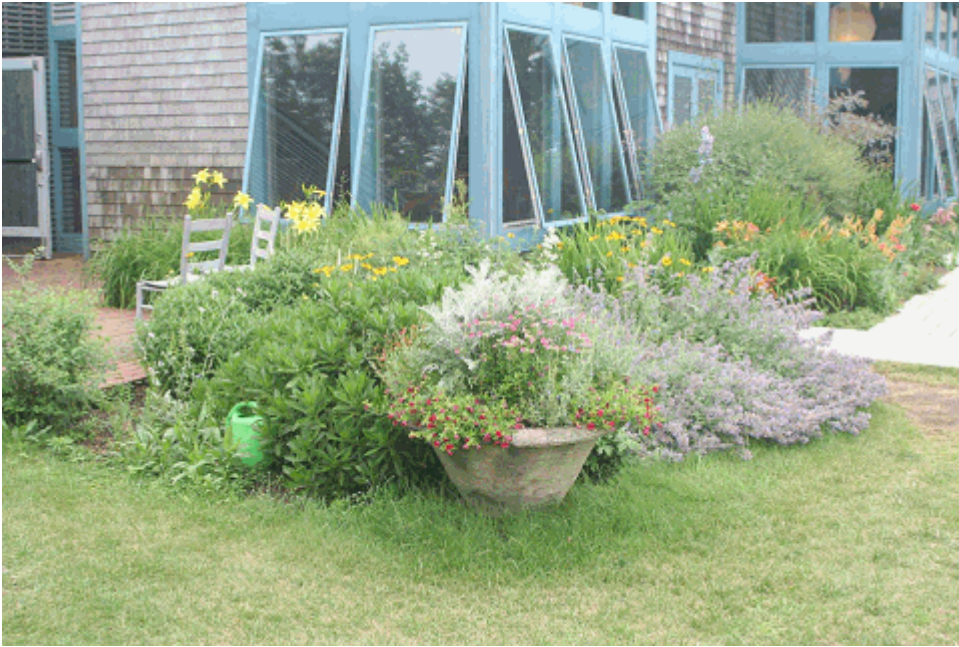
Figure 25. View looking southwest towards the Jordan Pond house and flower beds. Although the beds lack historic significance, they are beautifully arranged with perennials and annuals that bloom throughout the summer (OCLP, 2007).

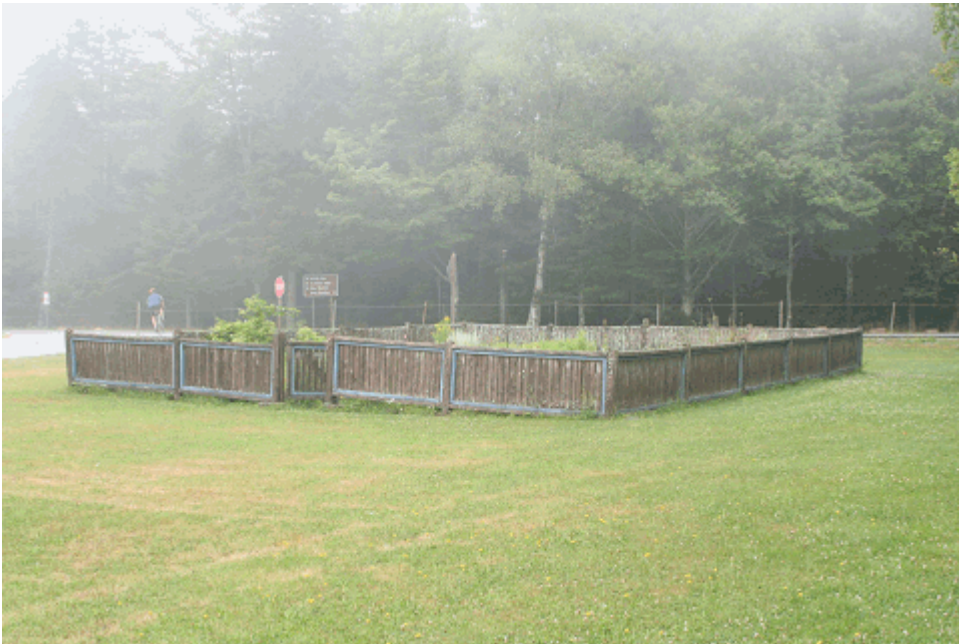
Figure 26. View looking east of the kitchen garden and wooden fence. Jordan Pond/Eagle Lake Motor Road (MR012) can be seen in the background (OLCP, 2007).

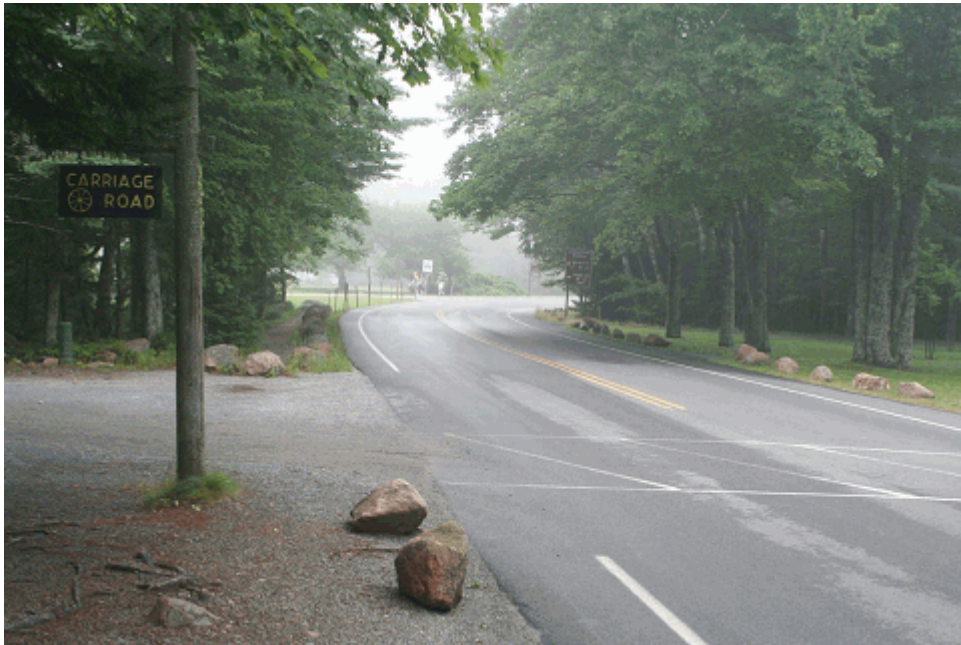
Figure 27. View looking northwest at the Jordan Pond/Eagle Lake Motor Road, realigned in 1963 (OCLP, 2008).

Following the historic period, the Jordan Pond/Eagle Motor Road was realigned in 1963, abandoning a section of the old road bed (Figure 27). In response to the increased visitation to the site, three parking areas were constructed between 1963 and 1986. Additional connecting trails from parking areas were warranted to provide visitors with a direct route to the Jordan Pond House and boat ramp.

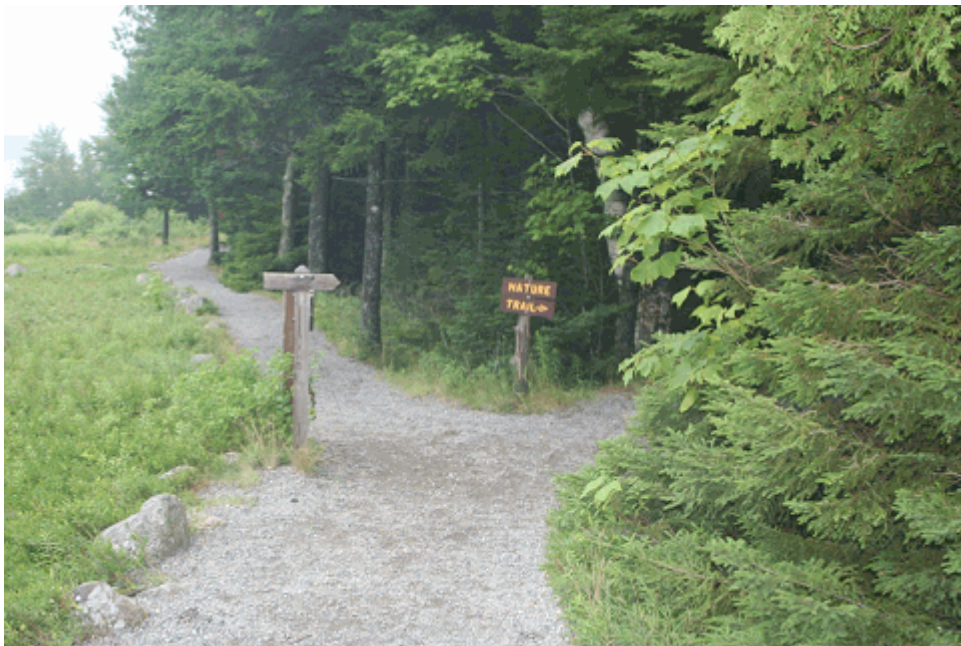
Figure 28. View facing northeast towards of a social trail along the historic tea lawn, as well as the trail head for the Jordan Pond Nature Trail (Trail #45). Note the stone markers along the social trail (OCLP, 2008).

Some of the hiking trails have been abandoned or rerouted to respond to user needs. Hiking trails that currently traverse or begin in the Jordan Pond House site include the Pond Trail (c.1874) [Trail #20], Asticou Trail (c.1881) [Trail #49], Seaside Trail (c.1893) [Trail #401], Jordan Pond Path/Jordan Pond Loop Trail (c.1896) [Trail #39], Jordan Stream Trail (c.1902) [Trail #65], Penobscot Mountain Trail (lower section, c.1917) [Trail #65], and Jordan Pond Nature Trail, original trail (c.1928-1929) [Trail #463]. In contrast, quite a few social trails have developed in the tea lawn area and other areas where signage is non-existent to direct visitors to their destination. In 1980, the original Jordan Pond Nature Trail was replaced with a new Jordan Pond Nature Trail [Trail #45]. In addition, the original carriage roads and associated structures are still extant within the Jordan Pond house site. All of the historic circulation systems are considered contributing features within the Jordan Pond area except for the post-1940 circulation systems (Figure 28).

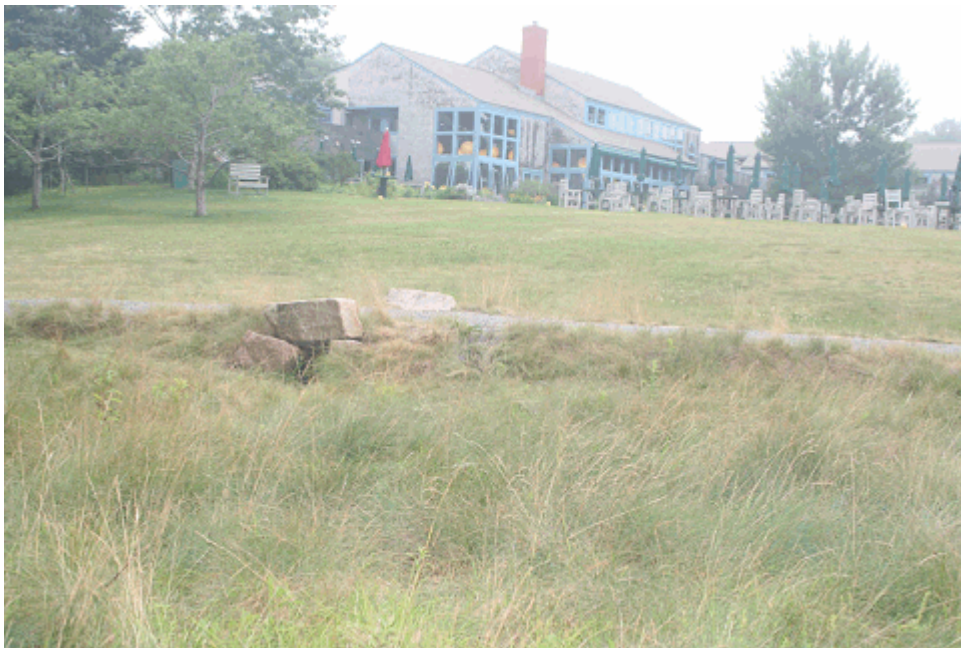
Figure 29. View looking south at the Jordan Pond House, constructed in 1982. Note in the foreground, the original Jordan Pond Nature Trail (Trail #463) (OCLP, 2008).

When the Jordan Pond House burned in 1979, the only features left from the fire were the stone chimneys. The new Jordan Pond House did not try to replicate the original building, but there are some qualities of the new building that call to mind some of its character. For instance, there is a rambling character to the structure, which mimics the previous building's form. Additionally, the building was constructed in almost the same location as the original building as an "L" shaped footprint. The architects chose to rotate the new building footprint slightly to the east, to take better advantage of the views to the pond. Cedar shingle siding, and the exposed timbers of the new building, also captured some of the qualities of the older structure, but the massiveness of the new building in comparison to the surrounding landscape sets it apart. The original low rambling house integrated into the landscape, whereas the new structure stands out as a punctuation mark (Figure 29).

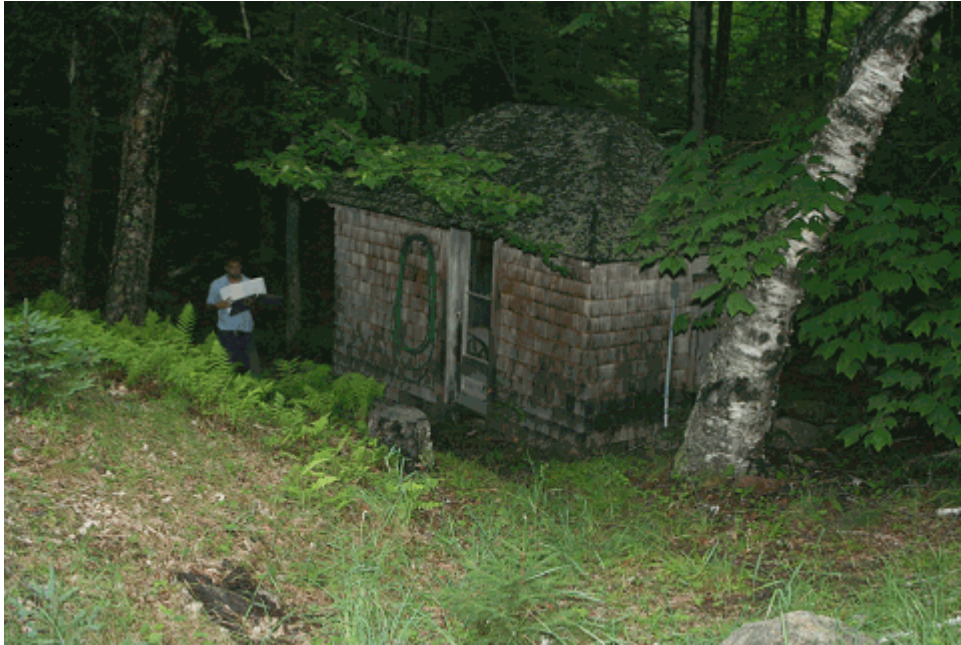
Figure 30. View looking southwest at the wood frame pump house, constructed c.1910 (OCLP, 2008).

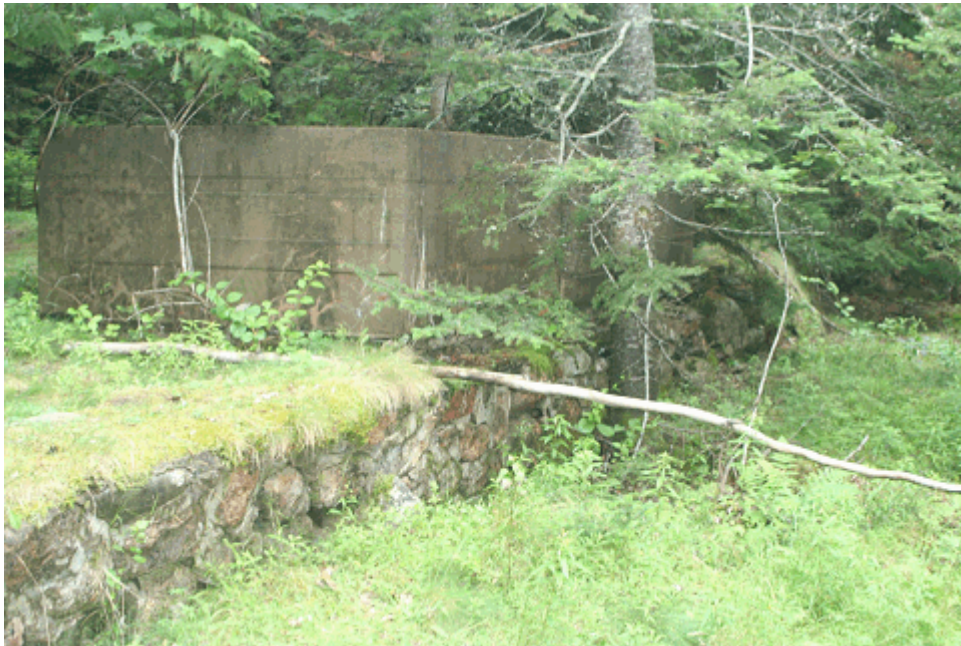
Figure 31. View of the McIntire ice house foundation, constructed c.1900s. The ice house operation was abandoned by the 1940s(OCLP, 2008).

On the southeastern shoreline an ice house was constructed to store ice cut from Jordan Pond. A service road ran directly to the building from Jordan Pond Road and the pond access point. Edwin Jordan obtained a eleven year lease from McIntire to operate his ice storage business, starting on October 1, 1919. "Eddie" Jordan continued the business into the 1930s. There is very little information regarding the date of construction for the ice house but the operation was abandoned by the 1940s.

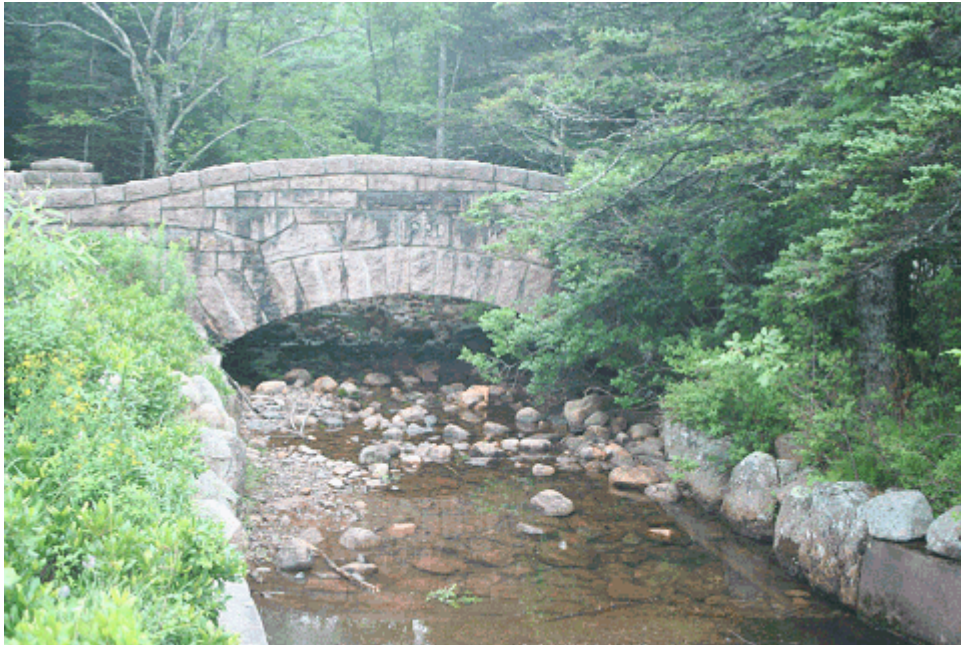
Figure 32. View looking southwest of the Jordan Pond Dam Bridge (constructed 1920) and Jordan Pond Dam and Spillway channel. Note the stone-lined channel corridor (OCLP, 2008).

The historic use of native stone in the Jordan Pond landscape is still evident around the edge of previous flower and vegetable gardens, planting beds, hiking trails, carriage roads, box culverts and headwalls along the abandoned park motor road, icehouse and pond access roads, and as part of the icehouse foundation. In the location of the dam and spillway, the channel is lined with stone.

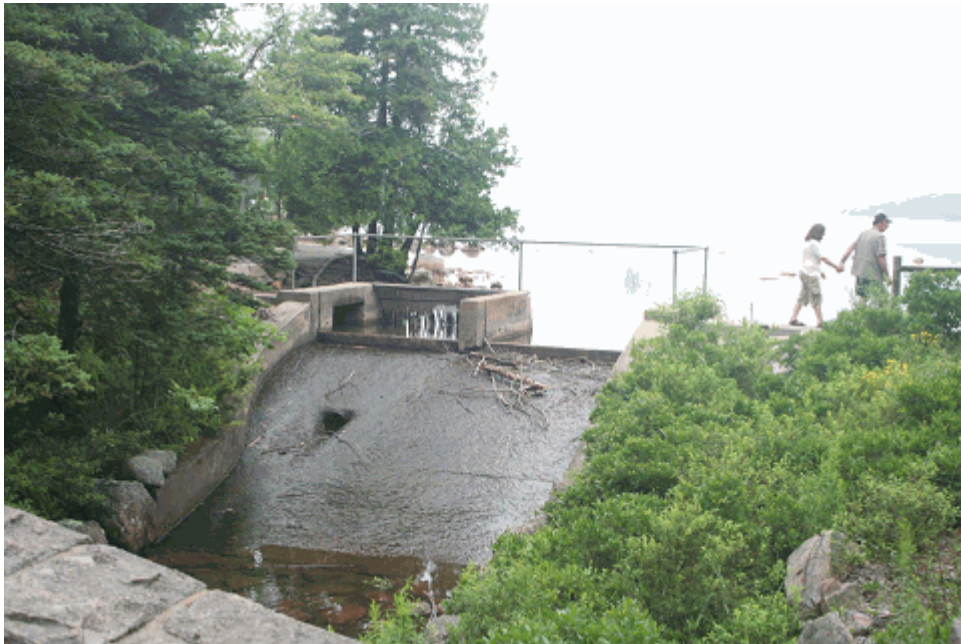
Figure 33. View looking northeast of the Jordan Pond Dam and Spillway (OCLP, 2008).

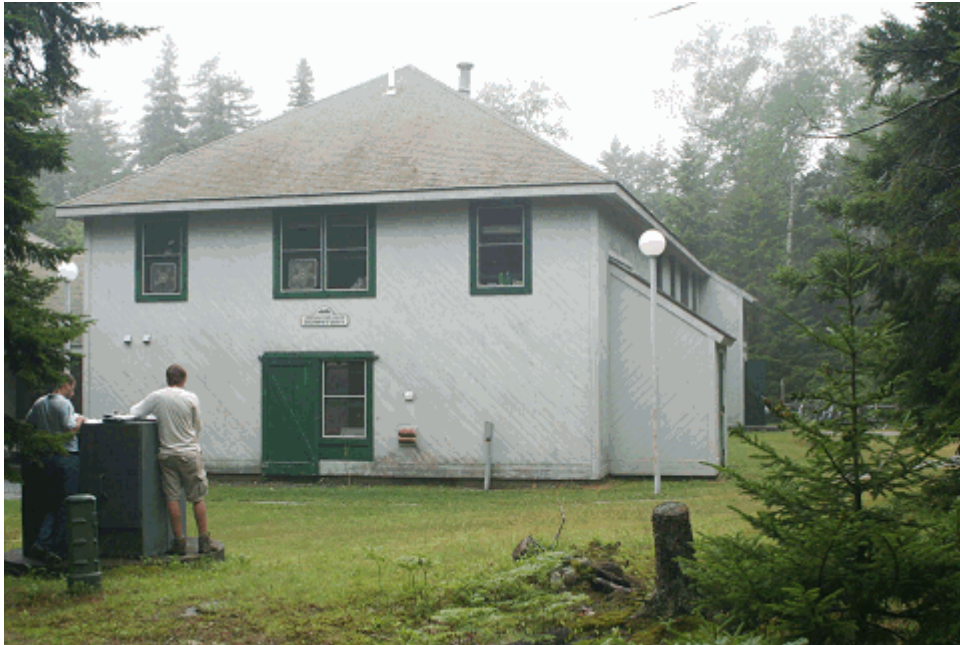
Figure 34. View looking southwest at the dormitory constructed in 1982 (OCLP, 2008).

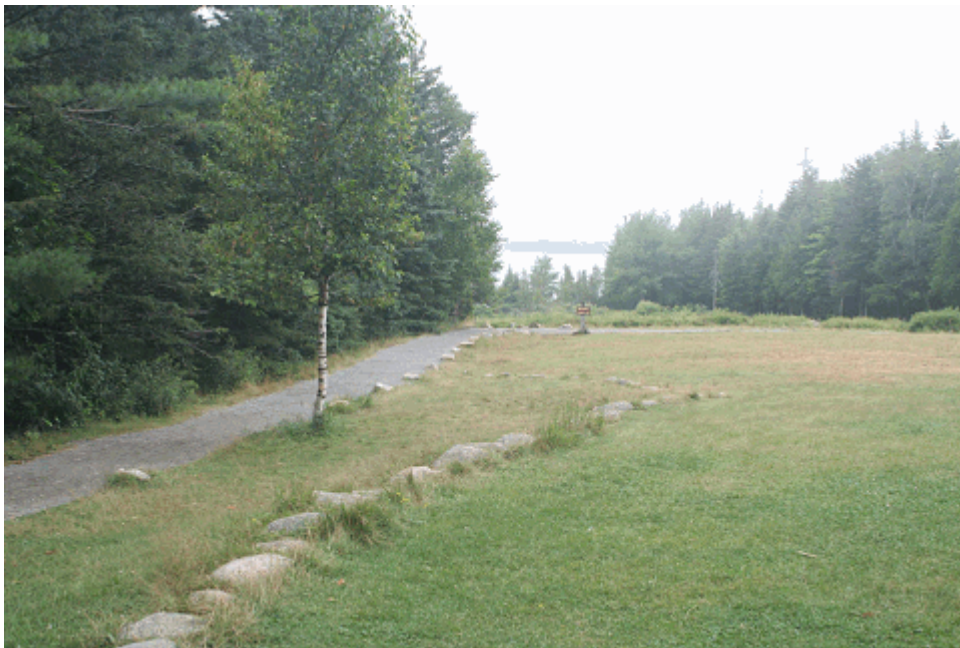
Figure 35. View looking north at remnant stones that once marked a planting bed laid out by Thomas McIntire (OCLP, 2008).

Native stones and boulders lining channels flower and vegetable gardens, planting beds, hiking trails, carriage roads, served to delineate areas. It also was also used as foundations, as seen with the icehouse. Finally stone served as engineered structures, evident in the box culverts and headwalls along the abandoned park motor road, icehouse and pond access roads. This use of stone was an obvious and practical choice for this region of Maine and consistent with the Picturesque styles.

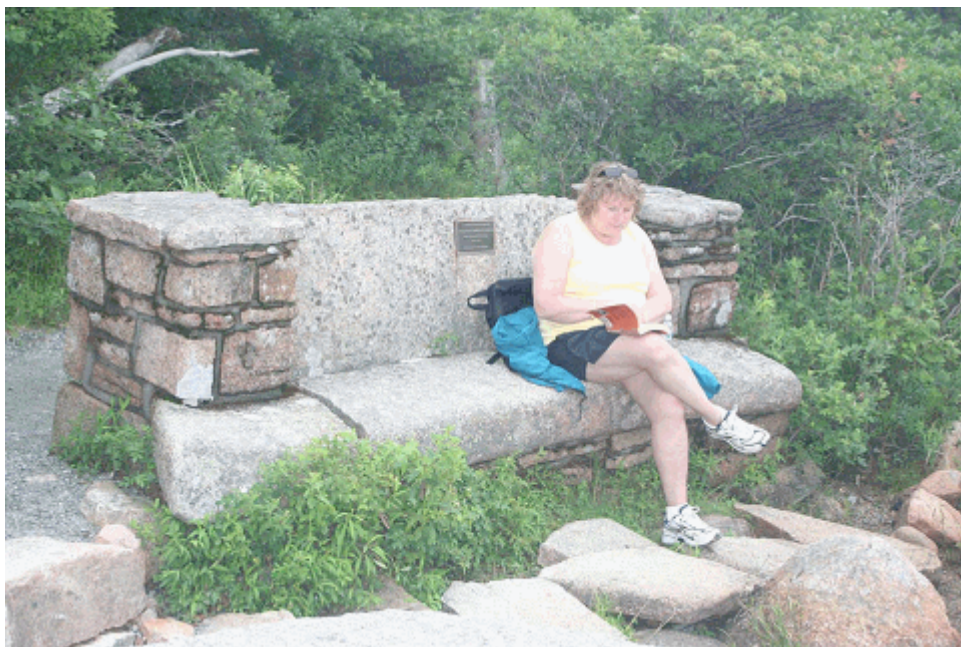
Figure 36. View of the Sarah Cushing Memorial Bench located along the Jordan Pond Loop Trail/ Jordan Pond Path (Trail #45). The bench was installed in the early 1930s (OCLP, 2009).
